Delaying Drainage From Prairie Potholes Protects Water Quality

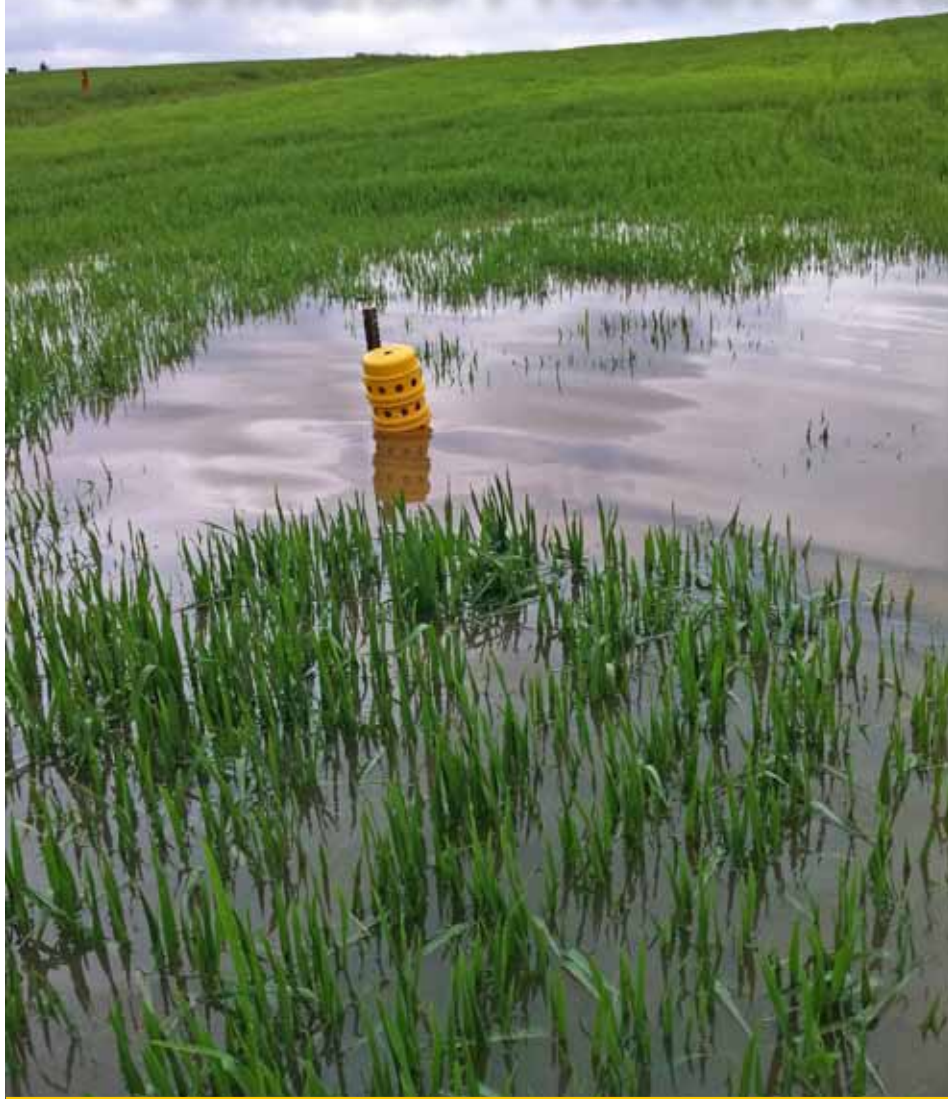
After a storm, a tile riser drains a pothole in a wheat field. Tile risers are perforated pipes extending a foot or more above the soil. Water flows into the holes in the pipe and then typically flows unimpeded and unfiltered into subsurface drains and eventually into streams, causing pollution. An ARS scientist has shown that a blind inlet (opposite page) provides a solution.

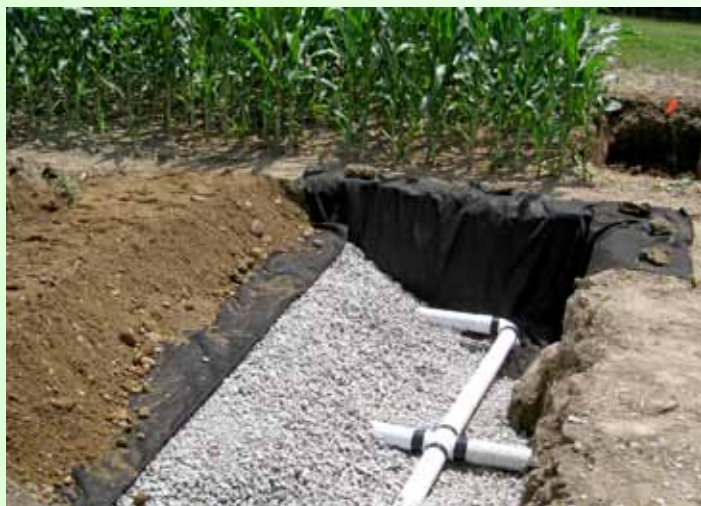
STAN LIVINGSTON (D3005-1)

Construction of a blind inlet. Septic tiles are placed on top of a layer of coarse limestone gravel, covered in a second layer of gravel, encased in landscape fabric, and backfilled with coarse soil to facilitate infiltration.

A blind inlet is similar to a French drain that channels excess water away from a building foundation. The scientists constructed their blind inlets by digging a square pit 3 feet deep at the lowest point of the pothole and then placing a layer of coarse limestone gravel in the bottom of the

pit. Septic tile lines were placed on top of the gravel layer and covered with another layer of limestone gravel. The second layer of gravel was covered by landscape fabric, and the rest of the hole was backfilled with coarse soil to facilitate infiltration.

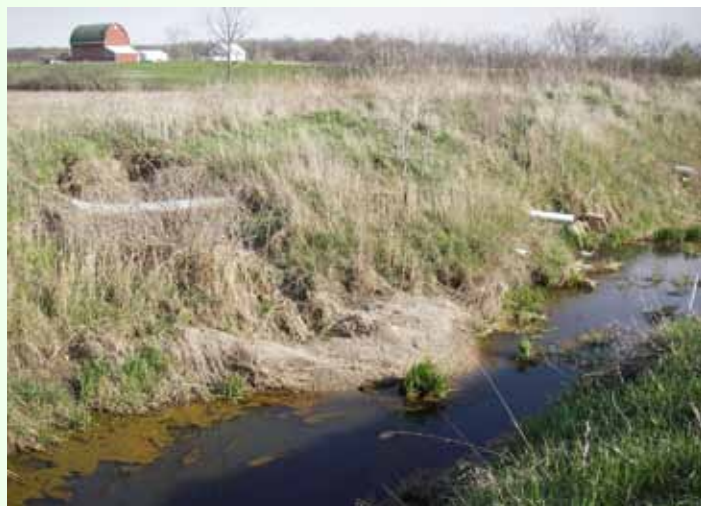
DOUG SMITH (D2768-1)

Water drained from potholes by tile risers is discharged via subsurface drains into the nearest field ditch without any filtering to remove excess phosphorus, nitrogen, or sediment.

The tile risers are also a key component of a serious long-term—and widespread—environmental issue. Water drained from potholes by the risers is discharged via the subsurface drains into the nearest field ditch without any filtration or processing to remove excess phosphorus, nitrogen, or sediment. In these landscapes, Smith says, field ditches function as first-order streams.
